# Pre-purchase RV inspection

| PREPARED FOR | VEHICLE | REPORT |
|---|---|---|
| Jordan Sample | 2019 Class C motorhome<br>Demonstration vehicle | BB-SAMPLE-001<br>Illustrative date: Sep 1, 2026 |

SAMPLE ONLY. All customer details, results and images in this report are fictional. This document demonstrates presentation and inspection coverage; it is not evidence of an inspection or a vehicle safety certificate.

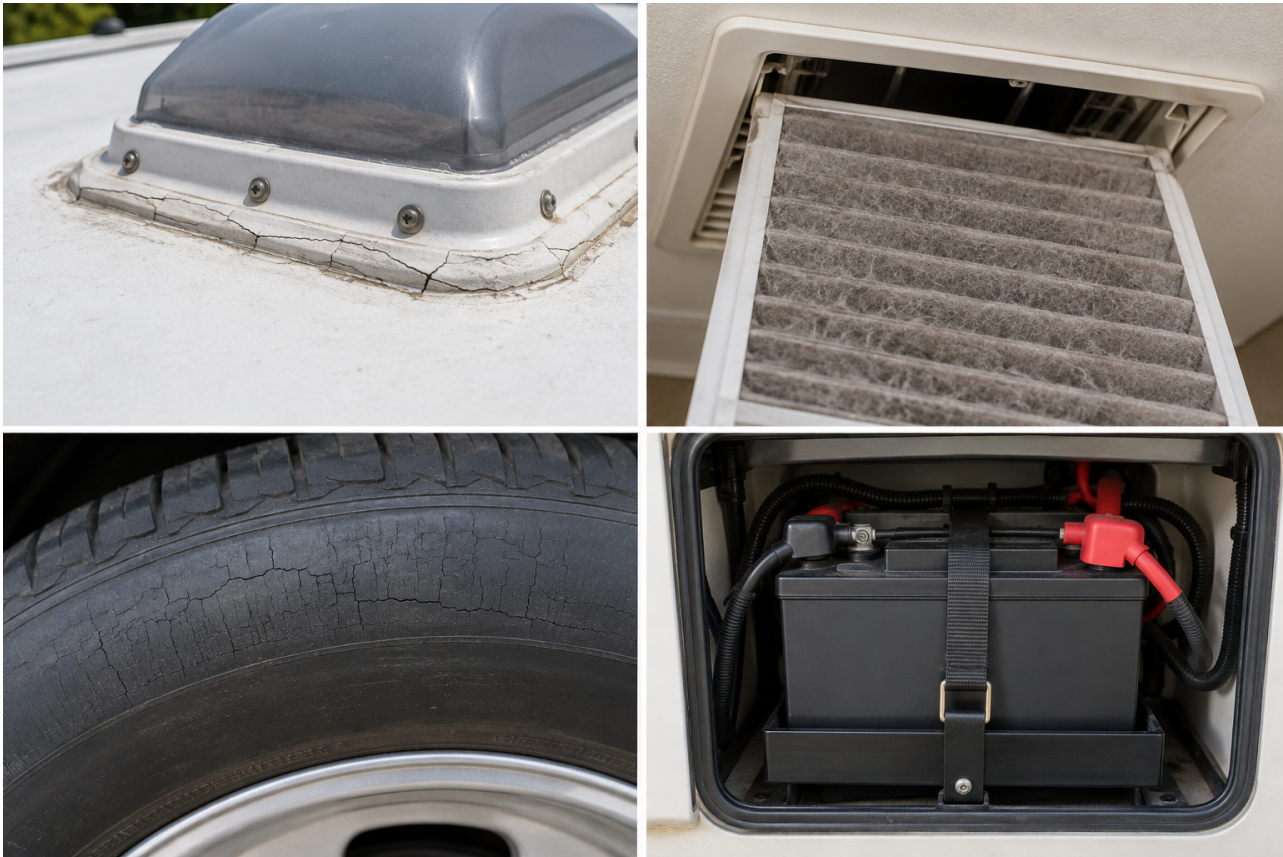
| PHOTO | EXAMPLE REFERENCE |
|---|---|
| A / top left | 8.7 - Roof vent sealant: visible separation to investigate and repair. |
| B / top right | 2.1 - HVAC return filter: cleaning recommended in this sample. |
| C / bottom left | 9.4 - Tire sidewall: cracking requires assessment before road use. |
| D / bottom right | 3.1 - Battery compartment: an example documentation photo, not a load test. |

2.1 / Maintenance: Dust on the return-air filter. Clean the filter and accessible vents; recheck airflow.

8.7 / Prompt repair: Visible separation in roof vent lap sealant. Repair and assess for moisture entry. Photo A.

9.4 / Safety: Visible sidewall cracking. Have a qualified tire specialist assess before road use. Photo C.
